PROJECT CROATAN

A Joint Project of the Maritime Archaeological and Historical Society and the Life-Saving Museum of Virginia, under the tutelage of John Broadwater, NOAA

I Introduction, Background and Site Description

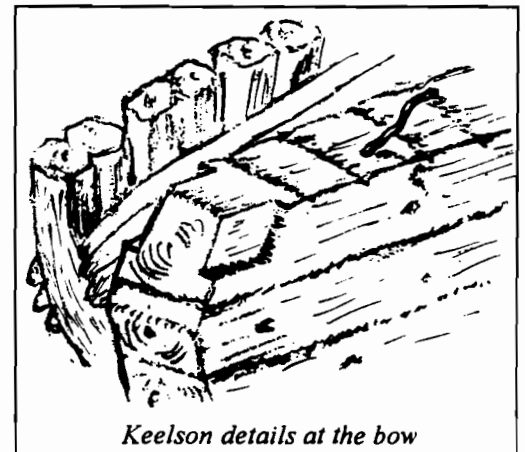
Keelson details at the bow

The wreck is the bow section of a wooden vessel characteristic of construction between 1850 and 1910. The 3-timbered keelson appears to have broken off at a mast step cut 6 inches deep into the top rider keelson (KN3) coincident with a keel scarf joint 40 feet from the bow. The keel, 15 frames, and the exterior and ceiling planks to a height of about 6 feet above the base of the keel survive. The widest remaining portion of the ship is 22 feet. (See centerfold for scale drawings.)

The keel is 12 inches wide and 16 3/4 inches thick at frame 15. Keelson timbers are untapered, about 13 1/2 inches wide and about 12 inches thick (KN1 11 1/2", KN2 12 1/2", KN3 11"). There is one flat scarf joint on keelson 1 beginning at 19 feet and ending at 23 1/2 feet. There are no scarf joints in the surviving portions of keelsons 2 or 3. The keel has a scarf joint beginning at 39 feet and ending at 44 feet. The aft keel timber of this scarf joint did not survive. There are five mortises cut into keelson 3. Four are about 3" wide x 12" long x 3" deep, beginning at 13 feet aft and at 6-foot intervals thereafter. These are likely seats for lower deck stanchions. The top rider keelson ends in a large unraked rectangular mortise, probably a mast step, 8" wide x 6 1/2" deep x unknown" long (the aft end of the keelson was abraded). The garboard strake is 12 1/2" by 4 3/4", exterior planks average 3 5/8" by 14" and ceiling planks 3 1/4" by 12". Planks tapered in width toward the bow to accommodate hull narrowing and also narrowed in thickness toward the bow.

◆Other diagnostics. Utley found two distinctive markings on the interior port side, one on a frame, and the other on the top rider keelson at 4' 11" on the centerline (see illustration).

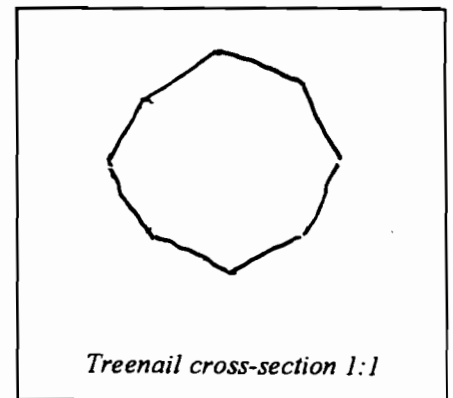
Treenail cross-section 1:1

- Treenails are the fastener of choice. They are found in regular but inexact patterns (Approximately one per plank per frame) attaching both floor and ceiling planks to the frames as well as being rarely used to connect keelson timbers and frame pairs. Treenails are one inch in diameter, with longitudinal striations characteristic of die-cutting with an octagonal cross-section (see illustration), and all exposed ends are split with wedges aligned athwartships. Lengths depend upon application.

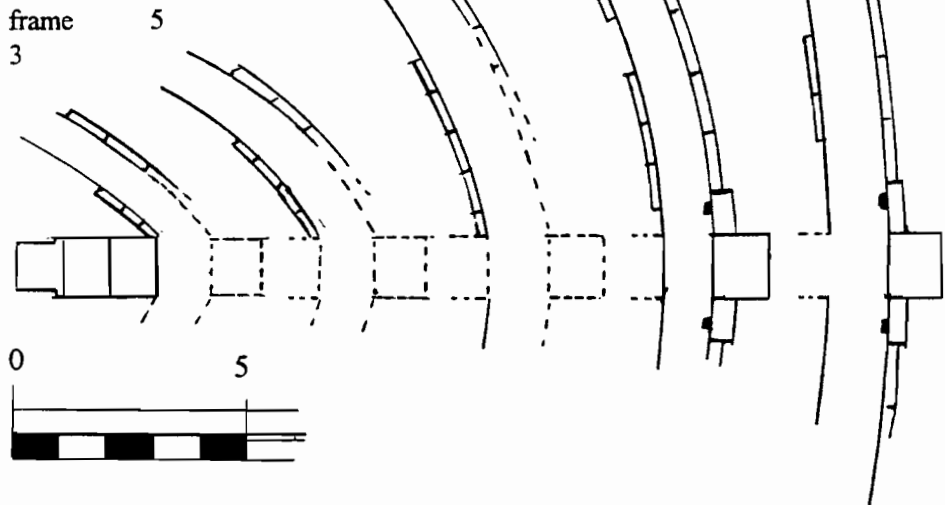
Body Plan

- **Height.** Curvature of the 6-foot-high (from bottom of keel) bow section shown in the body plan cross sections indicates that only the lower bottom portion, well under the waterline, survives. By continuing this curvature in conformance with hulls of the period, we estimate that the draft would have been from 8-12 feet and freeboard another 10 feet, accounting for a height from keel to main deck of approximately 15 to 20 feet, and a depth of hold of about 10 to 15 feet.

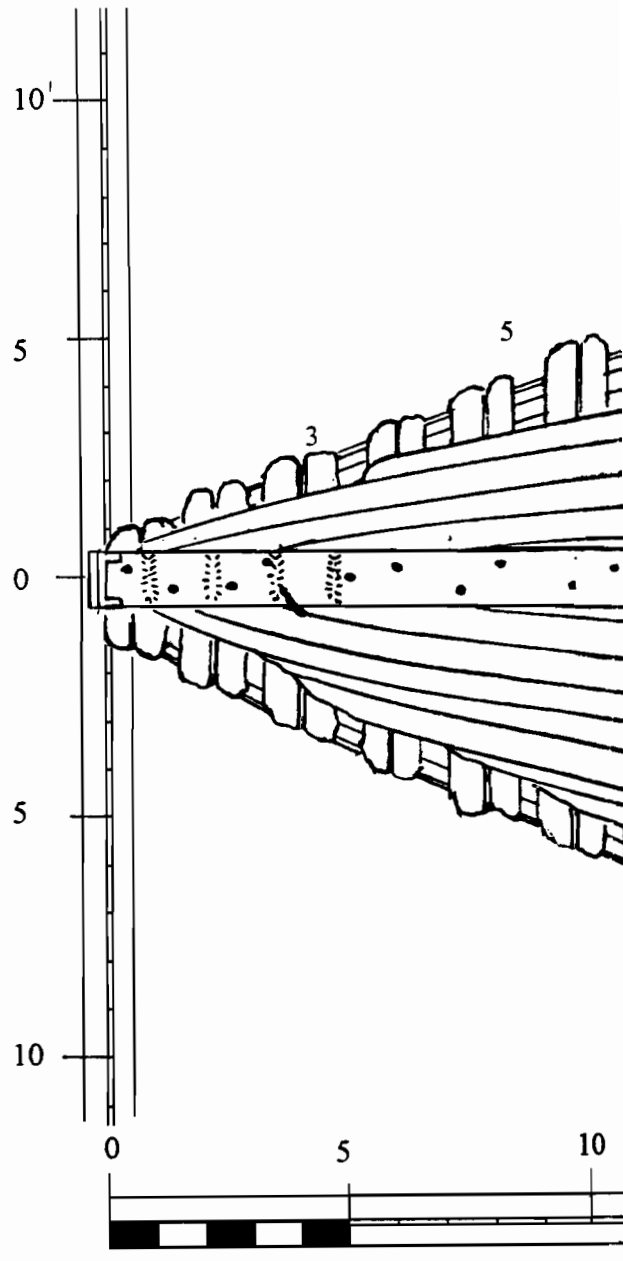
starboard exterior hull planking—fastener details (inverted view)

- Nail holes and a few surviving copper nails are indicative of copper or Muntz metal sheathing over the entire surviving outer hull. No sheathing remains. Nail patterns indicate that the hull had been covered more than once and therefore likely had a decade or more usage prior to foundering.

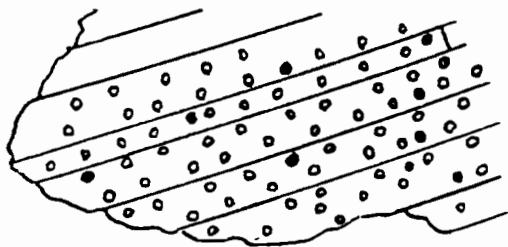
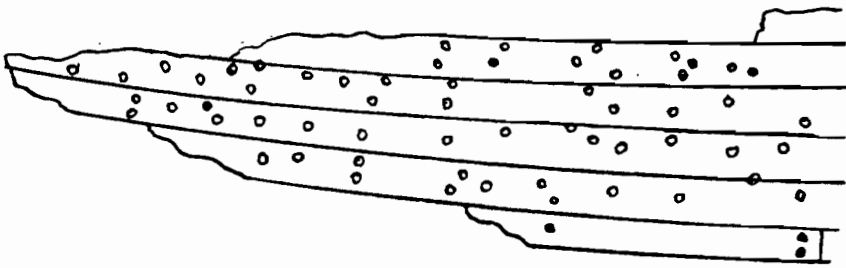
starboard ceiling—fastener details—
 ○ = treenail
 ■ = metal pin

--Bronze driftbolts are less common, used in the ceiling and stringers at irregular intervals.. A couple have collars, but most are now missing. The driftbolts are less than an inch in diameter, but are so eroded that exact measurement was not possible.
